U.S. Department  
of Transportation

**Federal Railroad  
Administration**

# **ACOUSTIC DETECTION OF RAIL CAR ROLLER BEARING DEFECTS: PHASE III, SYSTEM EVALUATION TEST**

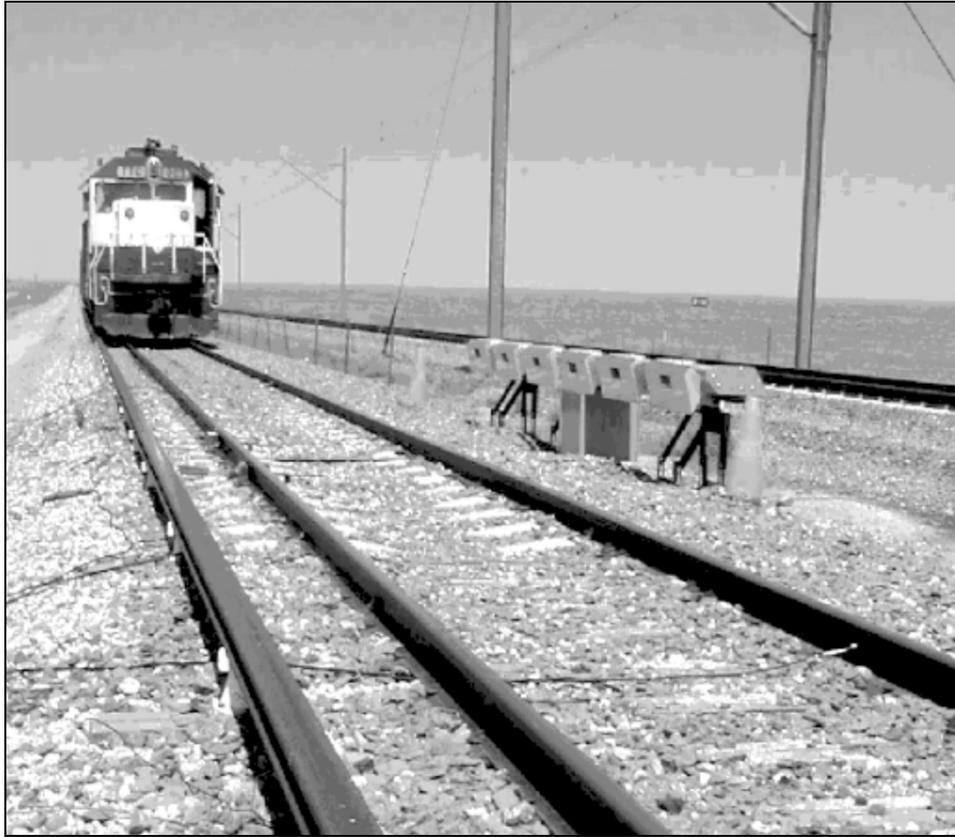
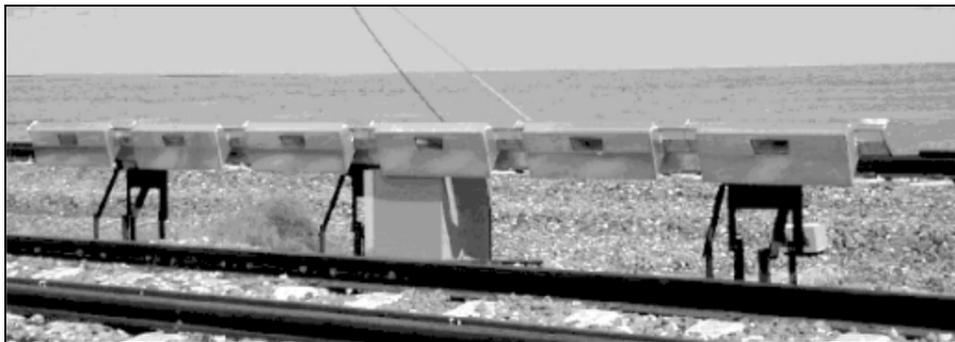
**Figure 1. Test Train and TCI Microphone Array**

Figure 1 shows the trackside microphone enclosure, and Figure 2 shows the track mounted wheel sensors. In addition to the wheel detectors clamped to the rail, a traditional island track circuit was used to alert the system for train presence. The wheel detectors, typically used in hot bearing detection systems, were used to calculate vehicle speed, wheel (bearing) position relative to the microphones, and to estimate bearing class from axle spacing. These wheel detectors are magnetic probes that respond to the proximity of the wheel flanges passing over the sensor element.

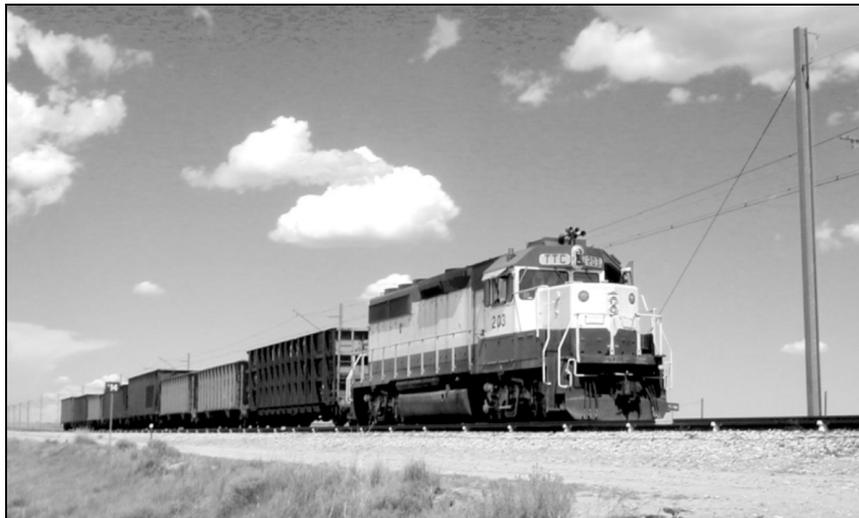
**Figure 3. Test Train Makeup**

Figure 3 shows the makeup of one of the test trains. Wheelsets and/or trucks were switched between cars to place defective bearings under different loads. Each car was weighed on a certified scale either before or after testing (see Section 2.0, Table 2). The test train was operated past the wayside instrumentation from both directions.

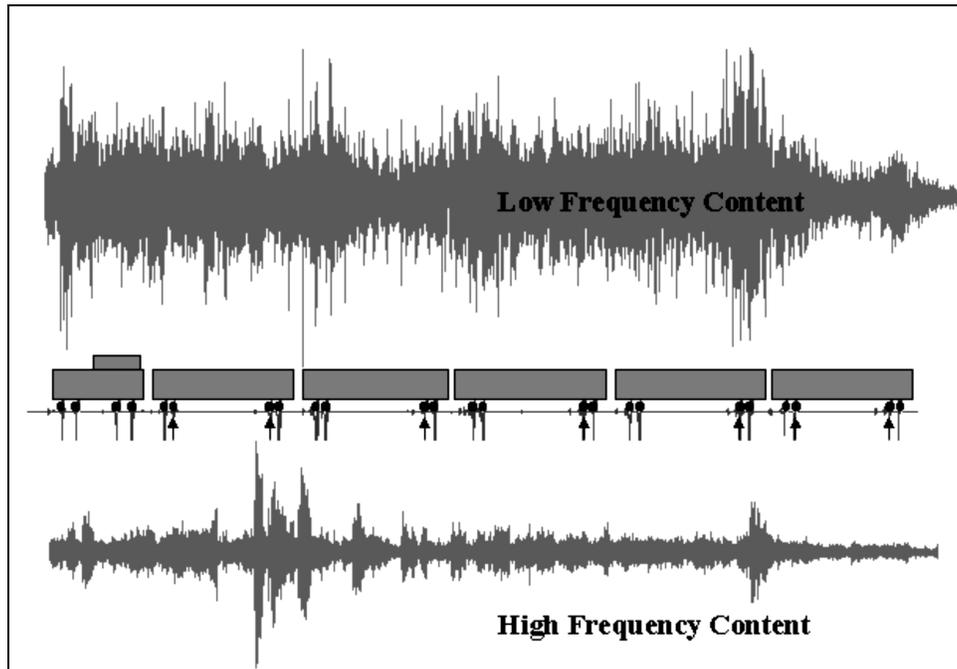
Figure 4. Typical Microphone Time History

A typical raw microphone time history for a passing train is given in Figure 4. Data has been broken down into the low-frequency content of the signal (above) and the high frequency (below). The graphic depicting the consist properly positions the wheelsets with respect to the signal, and the small vertical arrows give the position of defective bearings in this particular consist.

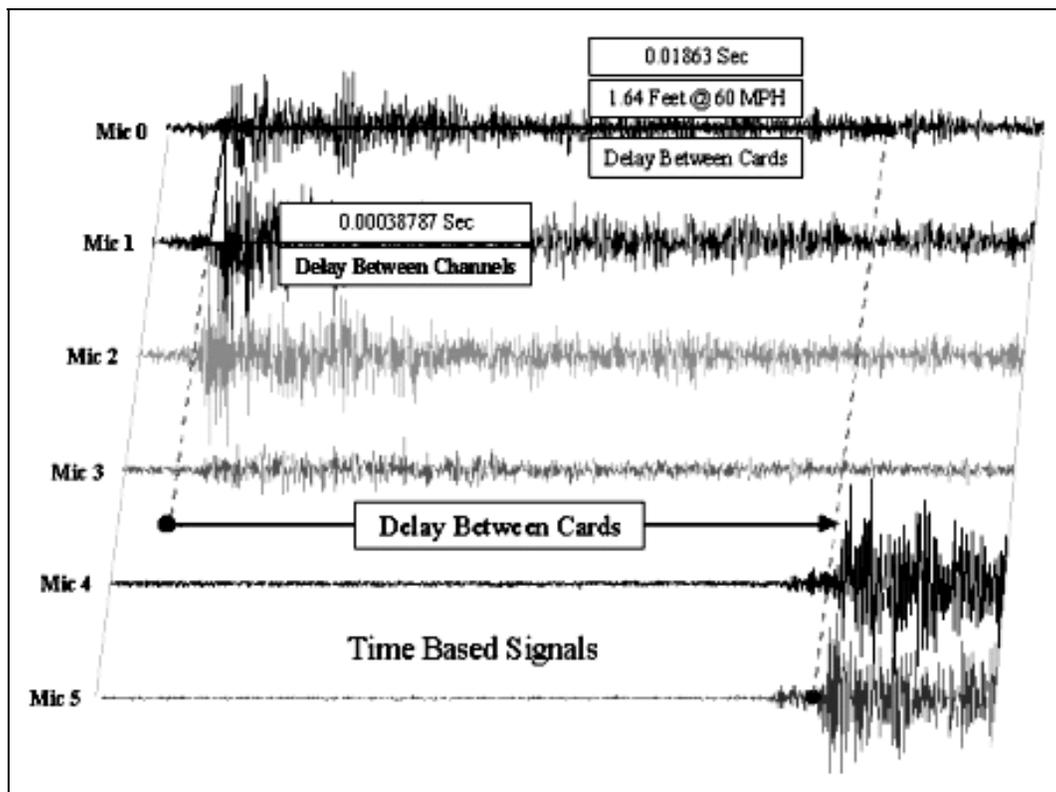
**Figure 5. Example of Multiple Microphone Signal Delays**

Figure 5 shows an example of the multiple microphone signals from the test, the small delay encountered between channels, and the larger delay encountered between A/D boards in the computer.

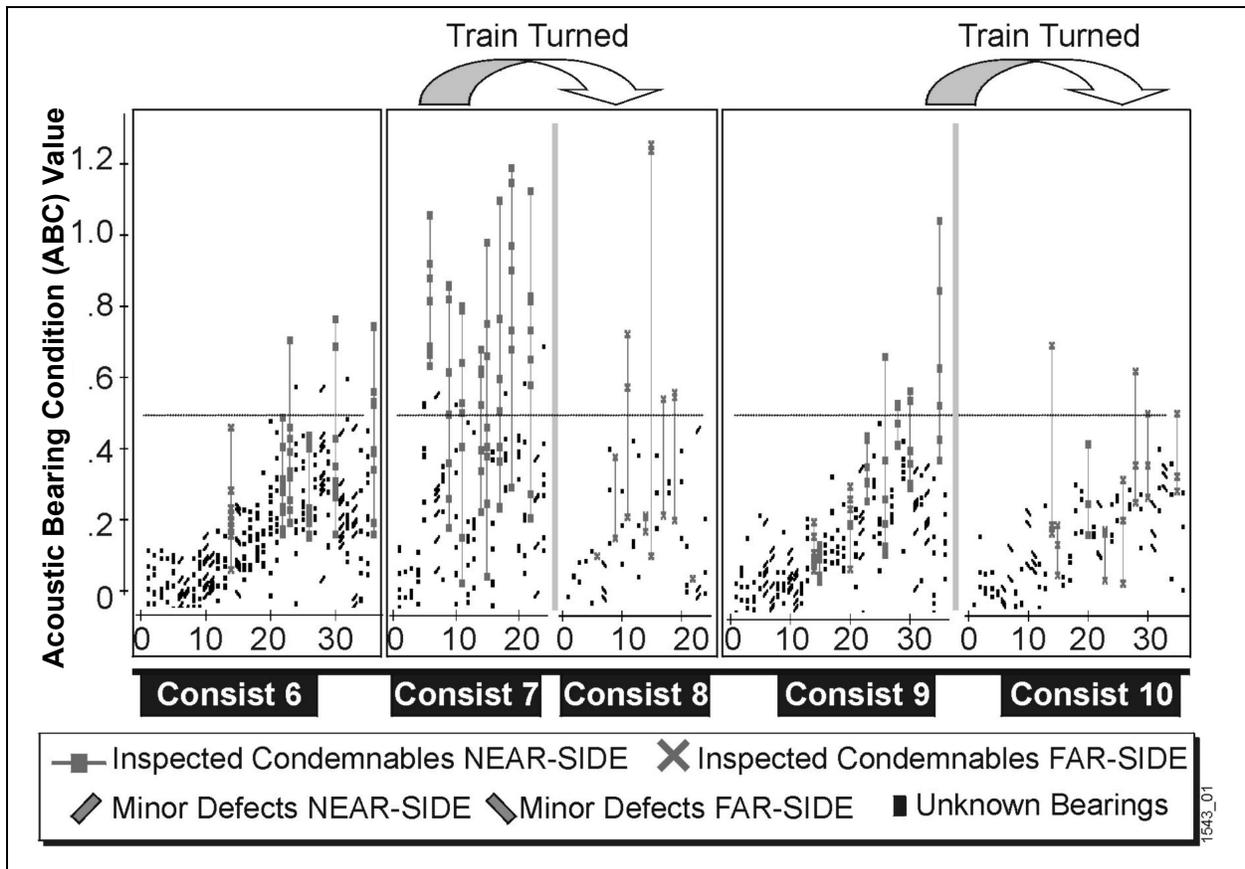
**Figure 6. Graphical Output for Expert Model Results**

The expert system model output shown in Figure 6 contains the results from the detector for all test runs with all five consists. It shows that consists 8 and 10 were run with the train direction reversed and defective bearings on the opposite side from the detector. Few defects were detected from those two consists compared to the previous consist before the train was reversed. The figure also illustrates that this expert system selects only defective bearings, with a few exceptions.

Figure 6 also illustrates that not all defects will be “heard” or recognized each time they pass the detector. Observe the numerous defects that have low ABC values, mixing with the good bearings. This analysis, complicated by the extraneous noise, mixes the defects with many of the unknown but assumed good bearings. A given threshold, shown by the dashed line here at an ABC value of 0.5, would not identify some defects. Besides illustrating a variation in detectable

acoustic emissions between passes, it can also be assumed that this expert system is not fully developed and may produce better results with additional data points (meaning more in quantity and variety of defective bearings and car types).

The expert system model developed from this data is a complex one. In spite of the noise issues, this model is almost accurate enough to be useful in revenue service, as Figure 6 shows. It is expected that further training with more and varied bearing defects would improve this performance.

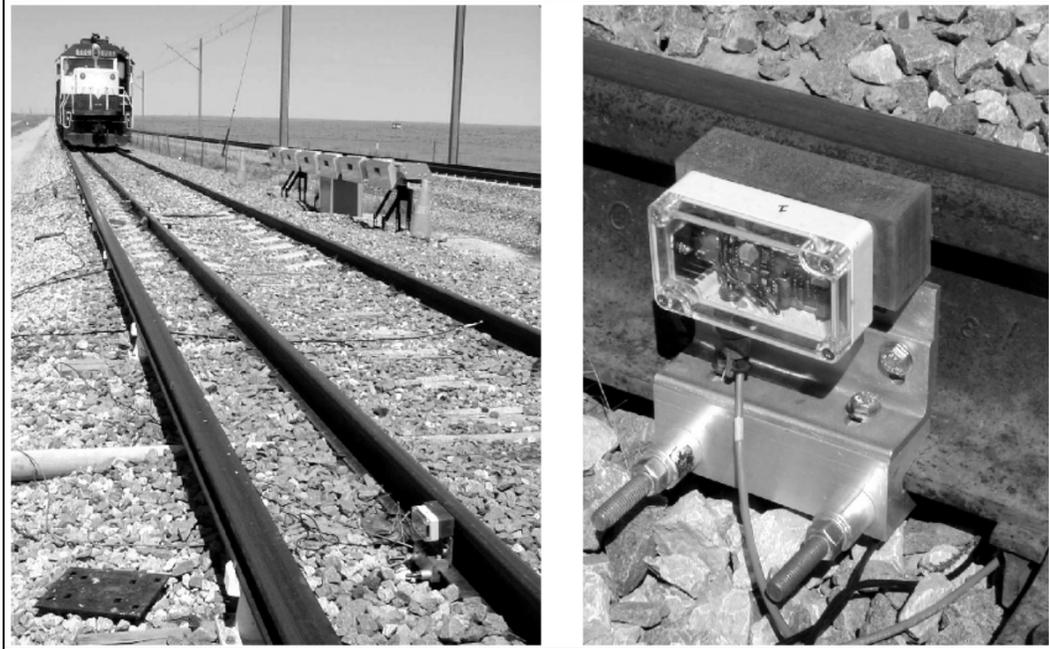
**Figure 7. FRA Test Train and Encore Electronics, Inc. Wheel Size Monitor**

Figure 7 shows two photographs of the tested wheel size monitor under development by Encore and placed in test during the FRA/TTCI wayside test program. The photo on the left shows the sensor mounted on the rail in front of the test train. A close-up photo of the electronic prototype monitor is on the right side. The prototype shown has its electronics encased in plastic, but the final design will have all sensing elements and the electronic components encased in a welded steel package.

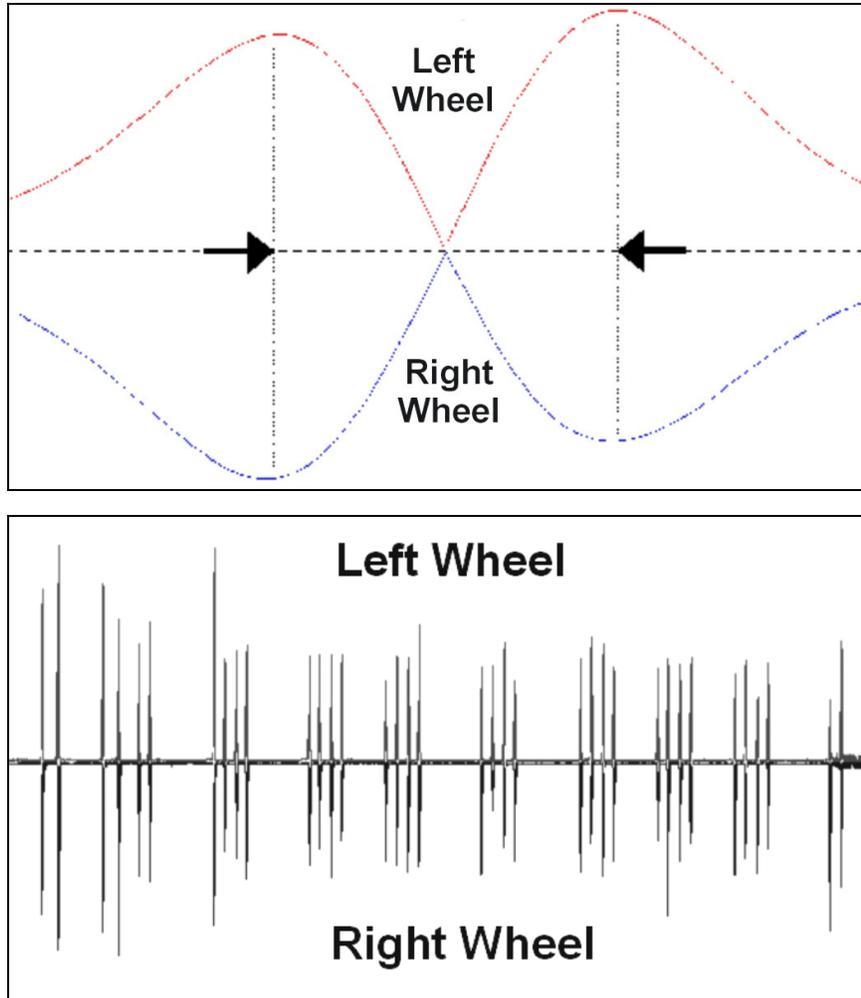
Figure 8. Encore Wheel Sensor Response

The Encore wheel monitor provides a signal, which is close to a “half-sine-wave,” for every wheel that passes (see Figure 8 for a detailed view of responses from a single wheel and test train). The peak response (changing slope & height) of the monitor’s signature is related to a passing wheel’s diameter. The monitor’s output is a measure of wheel curvature because the detector is sensitive to the proximity of a wheel’s outer flange. The monitor is typically fixed to the gage side of the rail. The output waveform of the monitor is also speed dependent because the waveform is proportionally compressed along the time-based axis as passing wheels run faster. This means that most applications require these monitors to be set up in pairs.

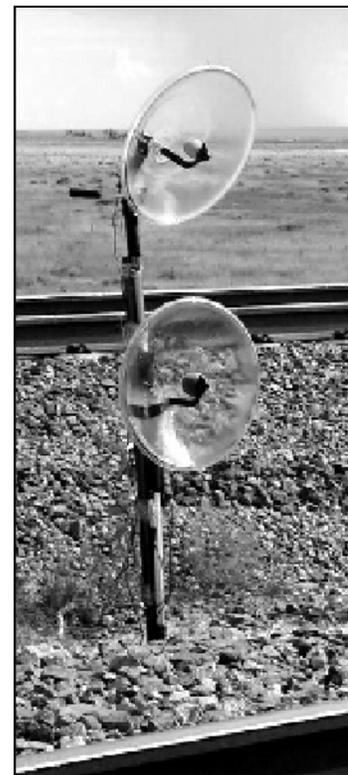
**Figure 9. NSEW Parabolic Microphones**

NSEW used four separate microphones during the Wayside Acoustic Test Evaluation program to record passing bearing signatures from the test trains. Two microphones were of the “parabolic” design and are shown in Figure 9, as they were mounted in the test recording program. A parabolic microphone is an ideal long standoff non-contacting sensor and is effective as a remote acoustic monitor of rolling element bearings. Acoustic signals emitted by defective bearings can be picked up from remote locations with a parabolic microphone. Even in the presence of high background noise parabolic reflectors can amplify sounds coming from specific line-of-sight locations.

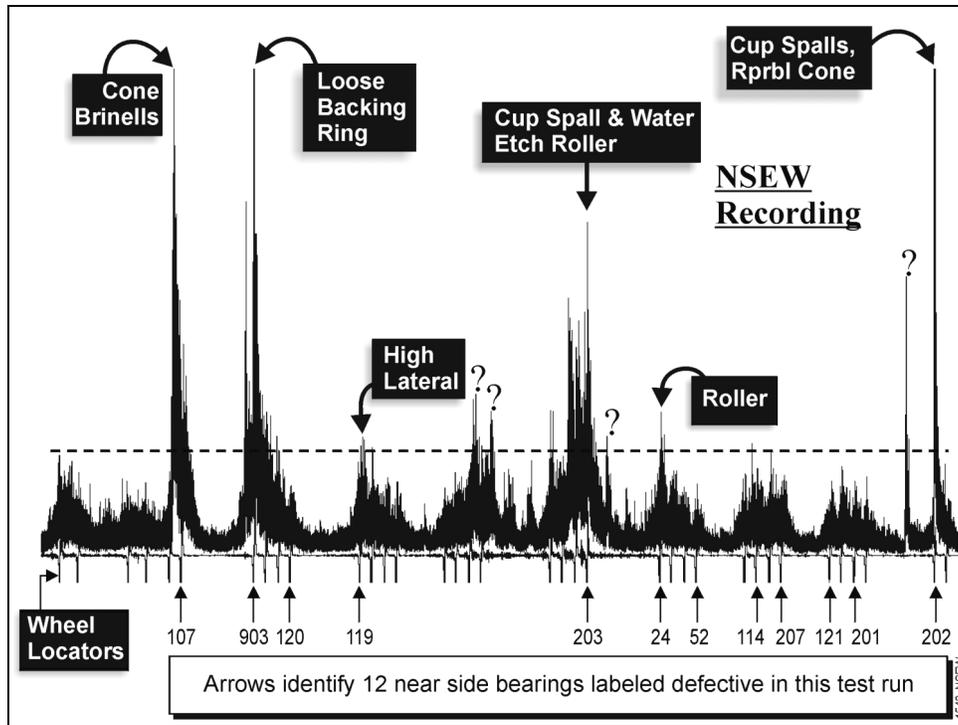
Figure 10. NSEW Recording of Passing Train

Figure 10 illustrates one of the NSEW recordings of a passing test train. The figure was derived from post processing one of the deployed microphones. Several specific bearings with known degraded components in the test consist can be identified from this simple graphic (i.e., 6 of the 14 total defects present, if wheel flats are ignored). Flags have been attached to the top of the defective passing bearings with the highest peaks in the figure. The arrows at the base of the display confirm that bearings were in the consist at the locations indicated by the flagged bearings. This simple diagnostic display is instructive because it uses only the peak rankings of the passing bearing’s processed acoustic output to accurately locate several defective bearings.

However, note that some defect types will not be found with this type of analysis because they may generate small amounts of acoustic output even though they contain defects. This can be seen from the graphic where arrows are pointing to bearings – yet they have small amplitude acoustic peaks above them.

With this simple diagnostic approach more (or less) bearings could be “culled-out” by changing the “detection” level (dashed line in the graphic), which is arbitrary, and in practice is set by experience. A pre-set detection level provides a higher (or lower) degree of detection accuracy depending upon the number of defects that pass their tendency to provide the high level outputs required of this scheme, and the details of the post-process chosen to generate the acoustic curves displayed. If a higher cut-off level is used to cull-out defective bearings, it tends to provide greater accuracy in defect identification — but fewer bearings are culled for inspection. Likewise, if the detection level is lowered with this scheme, many called-out bearings would contain no defects at all because even the best bearings generate some sound.

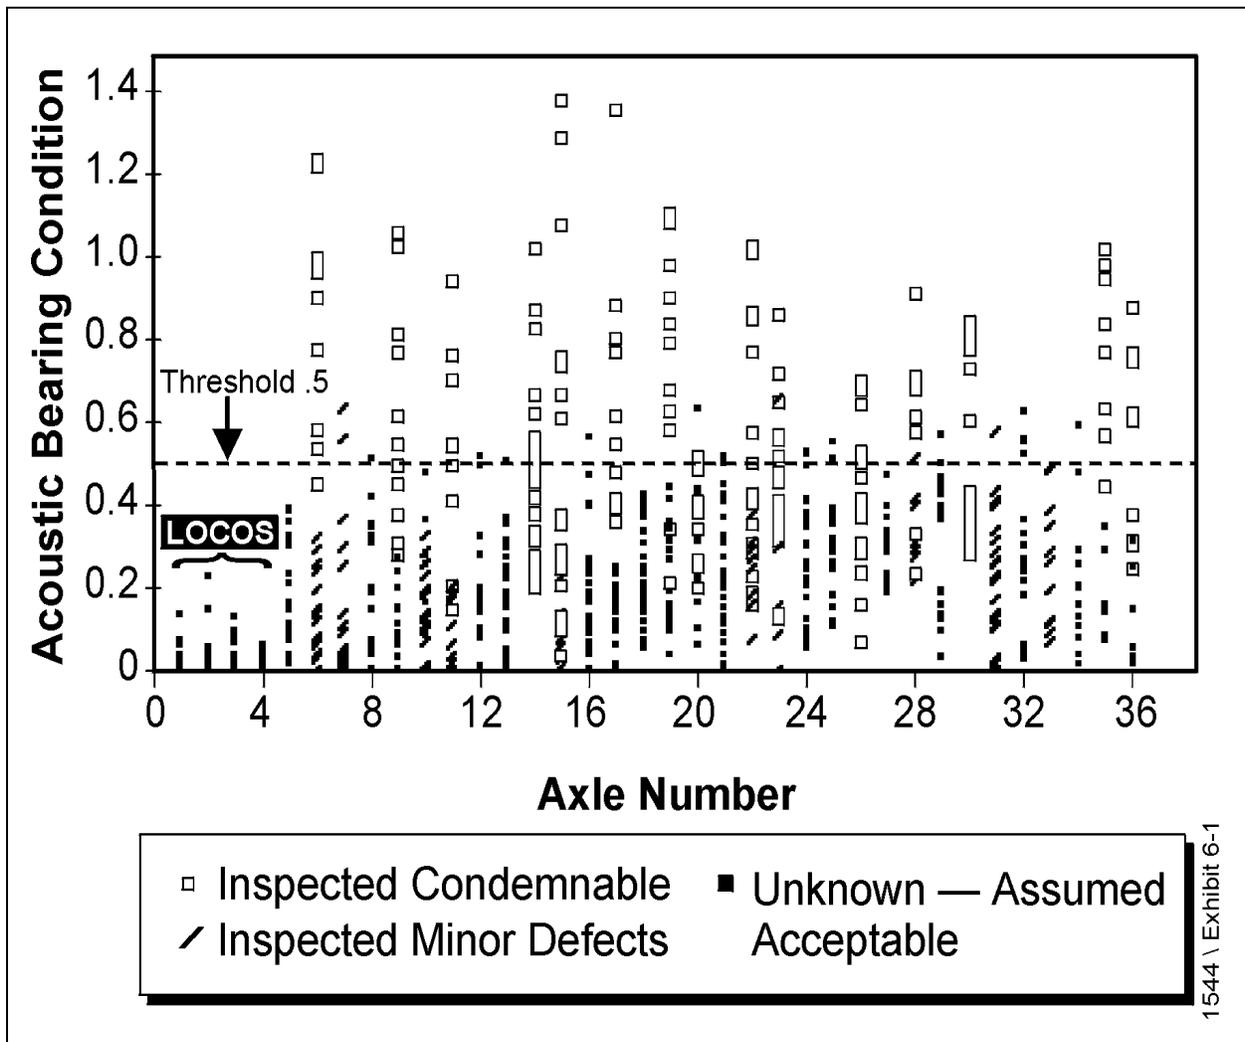
Figure 11. ABC Value versus Axle Number

The horizontal axis provides the axle location of the bearings as they went by the wayside array. Three separate consists, with axle counts ranging from 24 to 36, were run by the detector during the test cycle. The first four axles in the display represent locomotive bearings. All other data points are derived from test car bearings.

The large “squares” are from shop-confirmed inspected defective bearings with at least one or more condemnable mounted component(s). Right slanted “slash-marks” are from bearings with one or more, non-condemnable, yet visually detectable component defect(s). The small “lightly-shaded” dots are from bearings that were not inspected but were assumed to be acceptable by AAR standards.

There are 54 “condemnable” defects that have ABC values greater than 0.80 in the displayed plot. There were no non-condemnable bearings that produced ABC outputs above this arbitrary cut-off level.

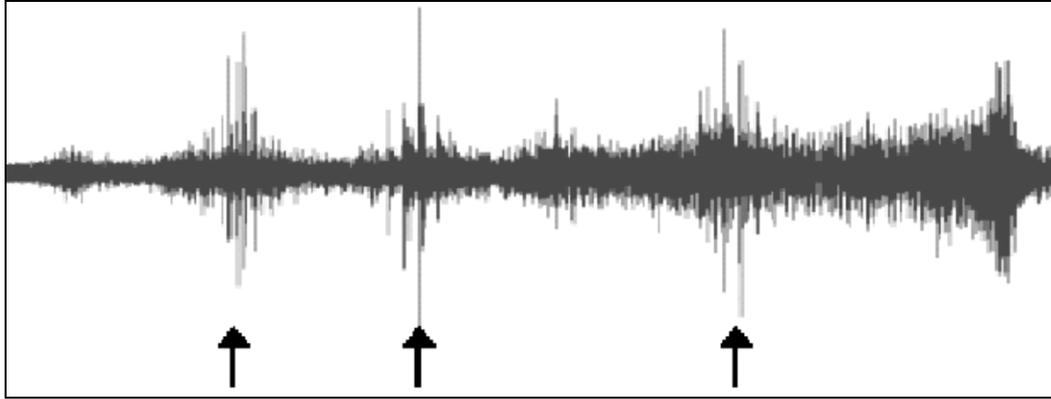
**Figure 12. Train Acoustic Time History with Wheel Flats**

Figure 12 contains a typical acoustic signature from a complete train pass that has at least three “flat” wheels. The center of each passing flat wheel is indicated with an arrow at the base of the plot. The wheel indicated by the arrow in the middle has a single flat spot on its periphery. The other flat wheels have multiple flats that generate more than one impact per revolution of the wheels. This is evident even from the highly compressed plot.

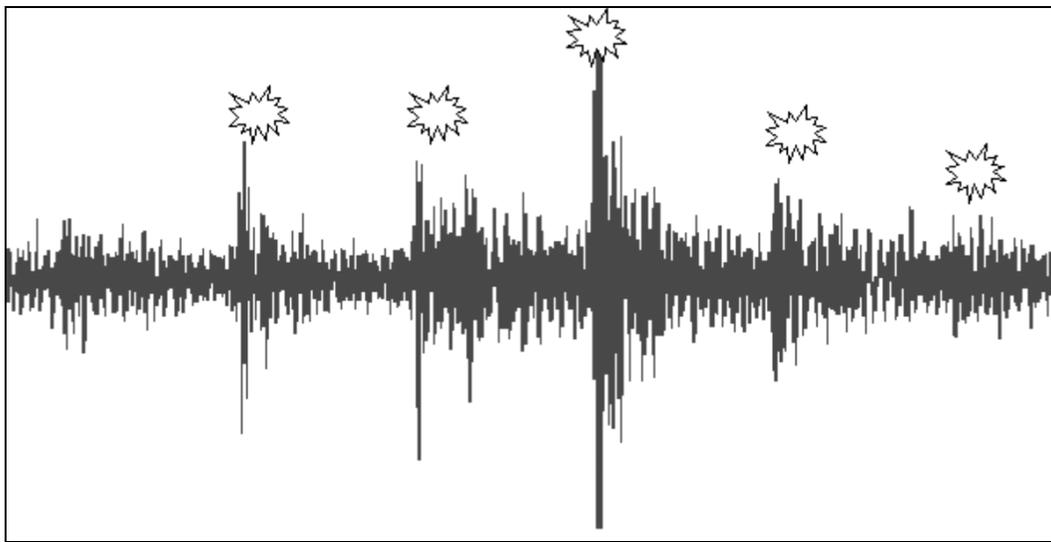
**Figure 13. Close-up View of Acoustic Time History of a Single Flat Wheel's Multiple Impacts**

A close-up view of one of the passing flat wheels is shown in Figure 13. Five impacts can be seen at equally spaced intervals. Even with the evidence of the impacts, however, there are many other acoustic variations intermixed in the signature. The question is whether the acoustic information from bearing defects can be detected even though the impacts are present. In most cases, the answer is yes. But in other cases, the bearing signature will be degraded. Since a large flat on a wheel can generate once per revolution signals with potentially broad band frequency content, it may ultimately “mask” the defect signatures produced by bearings.

The main reason the bearing signatures can often be discerned (even when wheel impacts are present) lies in the differing character of the frequencies generated by wheel flats versus bearing defects. Much like speech can be heard over hammering in a production plant, some bearing signals can be heard when wheel impacts are nearby or on the same wheel. An impacting wheel generates large amplitude signals, but a bearing generates a steadier repetitive periodic acoustic output. It is on these subtle differences that most of today's diagnostic schemes depend. Steady periodic signals from defective bearings essentially ride the wave of the impacting wheels. Just as specific words can be heard over hammer blows so can bearing defects. The flat wheels used in this test were not likely to have exceeded the removal criteria for a wheel flat detector per AAR standards.
